INEEL/EXT-2000-00100  
March 2000

***Field Operations Program  
Toyota RAV4 (NiMH)  
Accelerated Reliability  
Testing – Final Report***

**Idaho National Engineering and Environmental Laboratory  
Automotive Systems and Technology Department  
Idaho Falls, Idaho 83415**

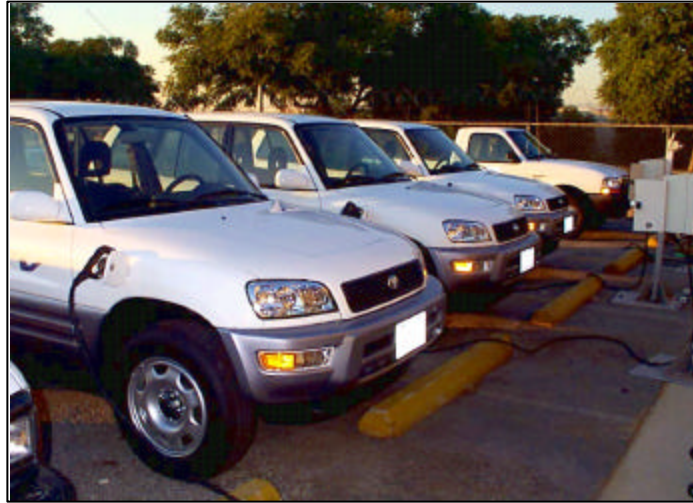
**Figure 1.** Some of Southern California Edison's Toyota RAV4s being charged with a Yazaki conductive connector.

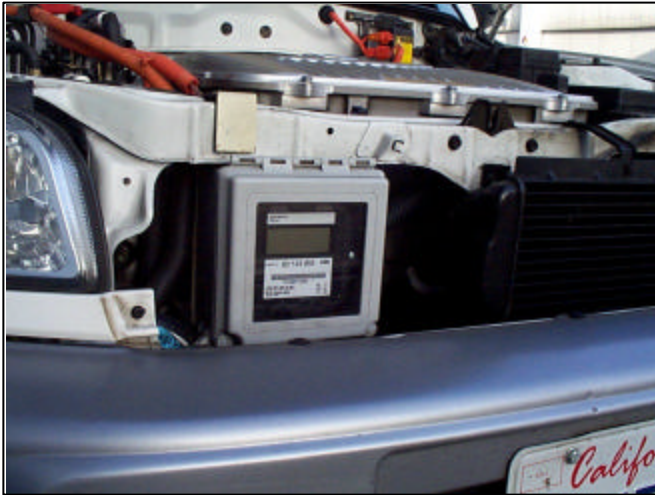
**Figure 2.** ABB kilowatt meter installed on a RAV4. It is located on the front of the passenger side of the RAV4.

SCE’s EVTC developed a meter installation specifically for electric vehicles. Using a type A1T-L single-phase kilowatt-hour (kWh) recording meter from ABB corporation, EVTC engineers removed the meter from the ABB-supplied base and installed it in a National Electrical Manufacturers Association (NEMA) enclosure. This enclosure allows installation for most vehicles and electric vehicle supply equipment (EVSE) hardware. SCE reached an agreement with Toyota to install and operate the meters. No vehicle modification was necessary for meter installation (Figure 2).

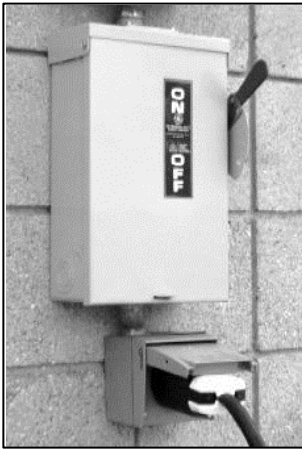
**Figure 3.** 240V electric outlets with NEMA 14-50 receptacles

240-V electric outlets with NEMA 14-50 receptacles were installed at the drivers’ private residences. The typical installation is shown in Figure 3. EVSE units (from either SCI Systems or Electric Vehicle Infrastructure) were prepared for the users to use at their residences by mounting them on carts (Figure 4). The units had NEMA 14-50 plugs, allowing easy connection to the electrical service. After the infrastructure was installed, the drivers were instructed in the operation of the electric vehicles and informed of the Accelerated Reliability Testing procedures and requirements.

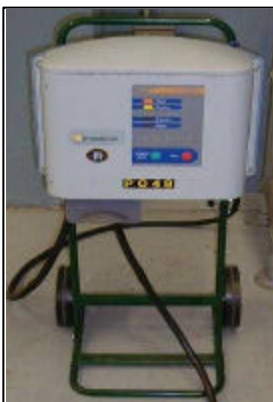
**Figure 4.** Electric Vehicle Supply Equipment (for charging) mounted on a cart (from the Electric Vehicle Infrastructure Company).

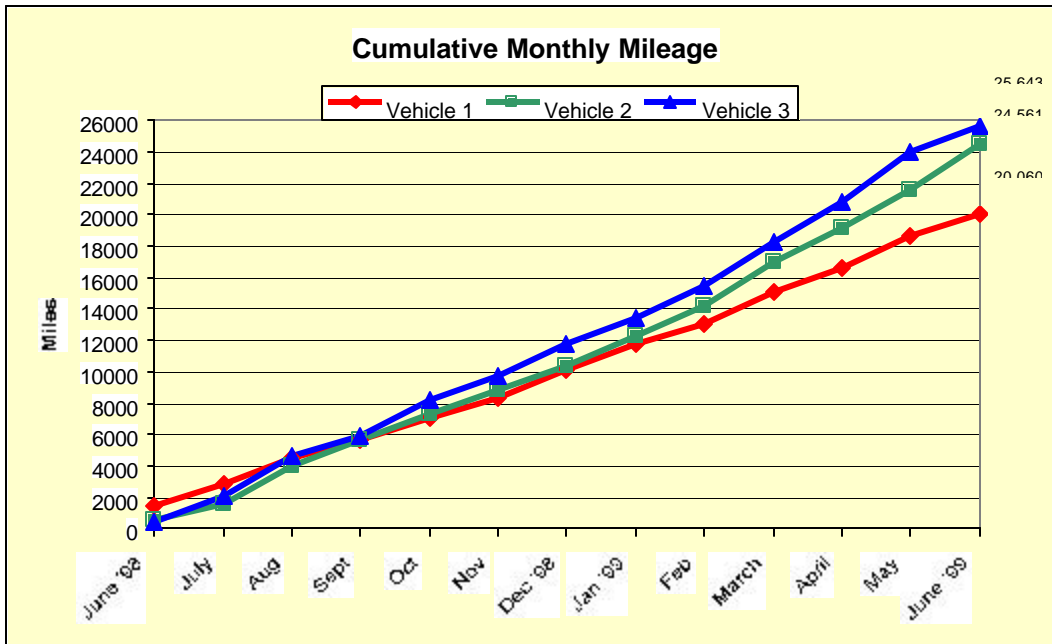
**Figure 5.** Cumulative (monthly) mileage for the RAV4 test vehicles.

The final odometer readings for the three RAV4s for the year ended June 30, 1999 were 20,060 (Vehicle 1), 24,560 (Vehicle 2) and 25,643 miles (Vehicle 3). The miles accumulated each month is shown in Figure 5. The monthly mileage, as shown in Figure 6, varied by as much as 1,800 miles when the vehicles were in service. This variance was generally not due to the vehicle being out of service or unavailable; more miles were accumulated when personnel and time were available to drive extra cycles, and it was lower if the primary driver was unavailable (vacation or travel). All of the vehicles were new when testing began in late June 1998, with 8 to 17 miles on the odometers.

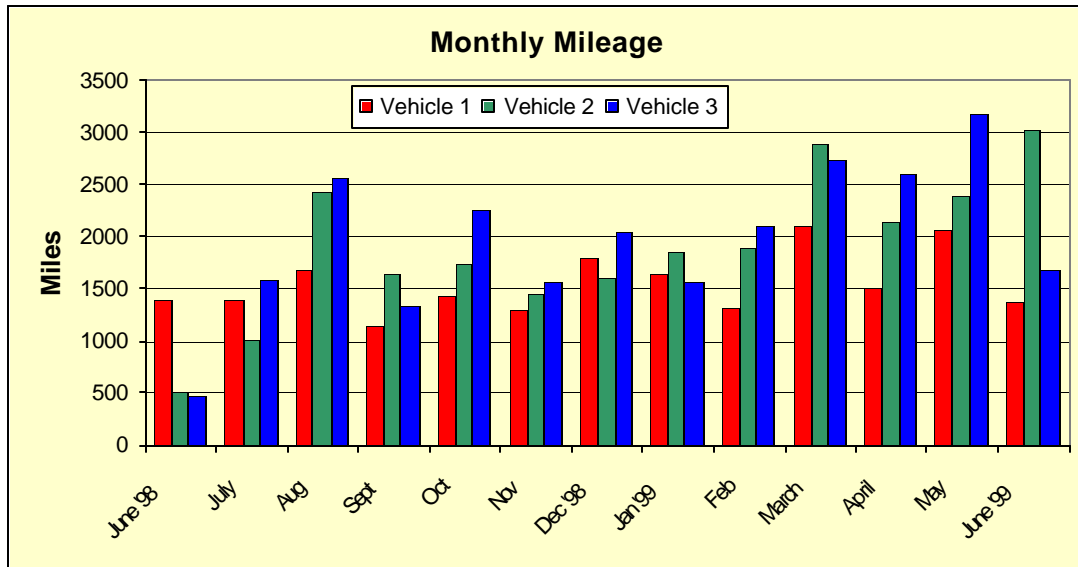
**Figure 6.** Monthly mileage accumulated for each vehicle.

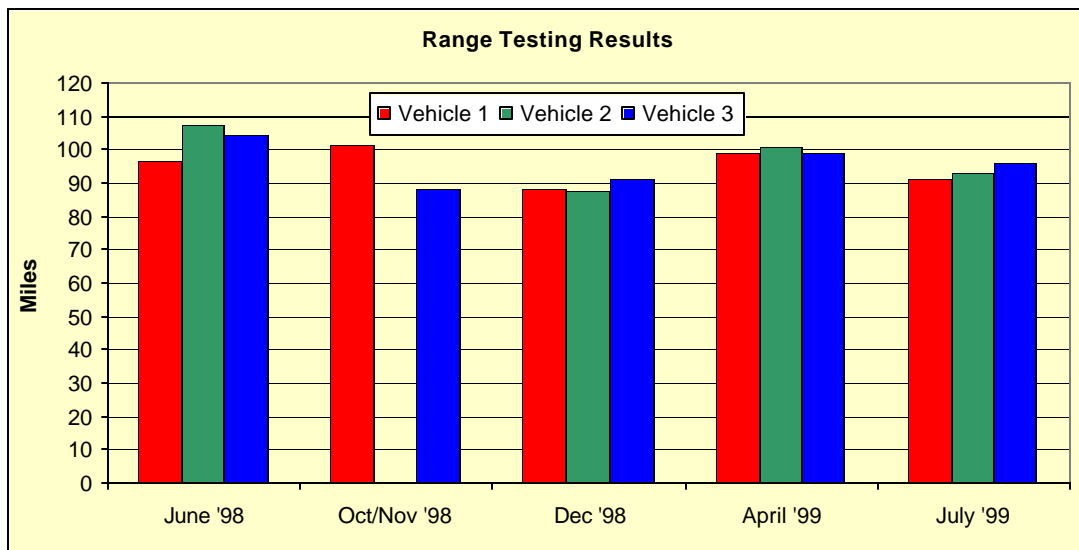
**Figure 7.** Urban Pomona Loop range testing results. Vehicle 2 was not tested during fall of 1998.

The RAV4s were range tested when they were delivered to SCE and during subsequent evaluations. Testing was conducted on the "Urban Pomona Loop" (a city driving route of approximately 20 miles with about 50 traffic signals and stop signs) with minimum payload (driver only) and no auxiliary loads. Most of the tests (Figure 7) were conducted with all three vehicles following each other in order to minimize the effects of varying ambient conditions, traffic, and driving style. The final ranges listed in Table 2 are the mileage readings when reaching the "stop condition" (flashing charge light).

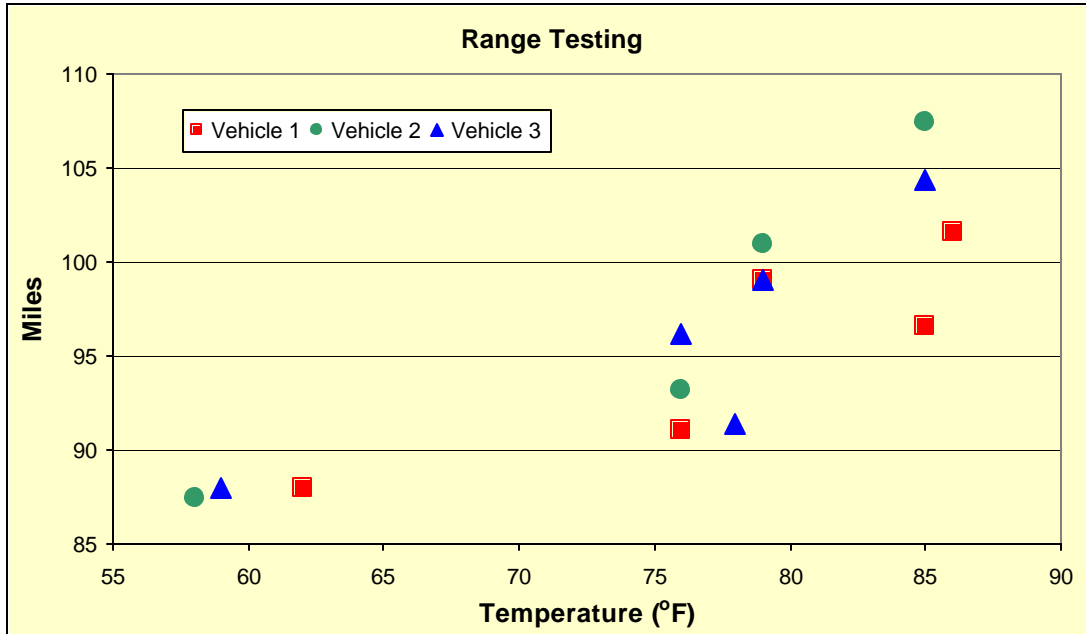
**Figure 8.** Range testing results for the three RAV4s. The bottom scale is the average temperature at test time and the left scale is the range result in miles.

As seen in Table 2, the range for all three vehicles varied from 87.5 miles to 107.5 miles. The reasons for the variation in range are not completely clear. However, the most obvious possibilities are declining battery capacity, the effect of ambient temperature on battery capacity, and the so-called "memory effect." Although the range varied directly with ambient temperature (Figure 8), the data was not clear enough to make a definite conclusion; several causes probably contributed.

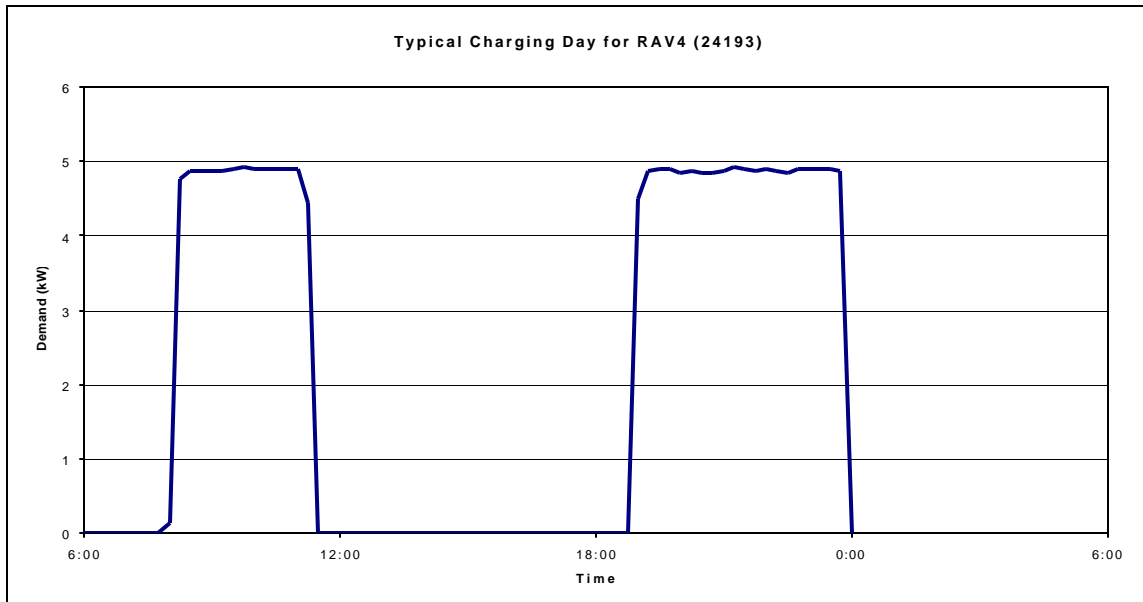
**Figure 9.** AC kWh demand for Vehicle 3 (24 hours).

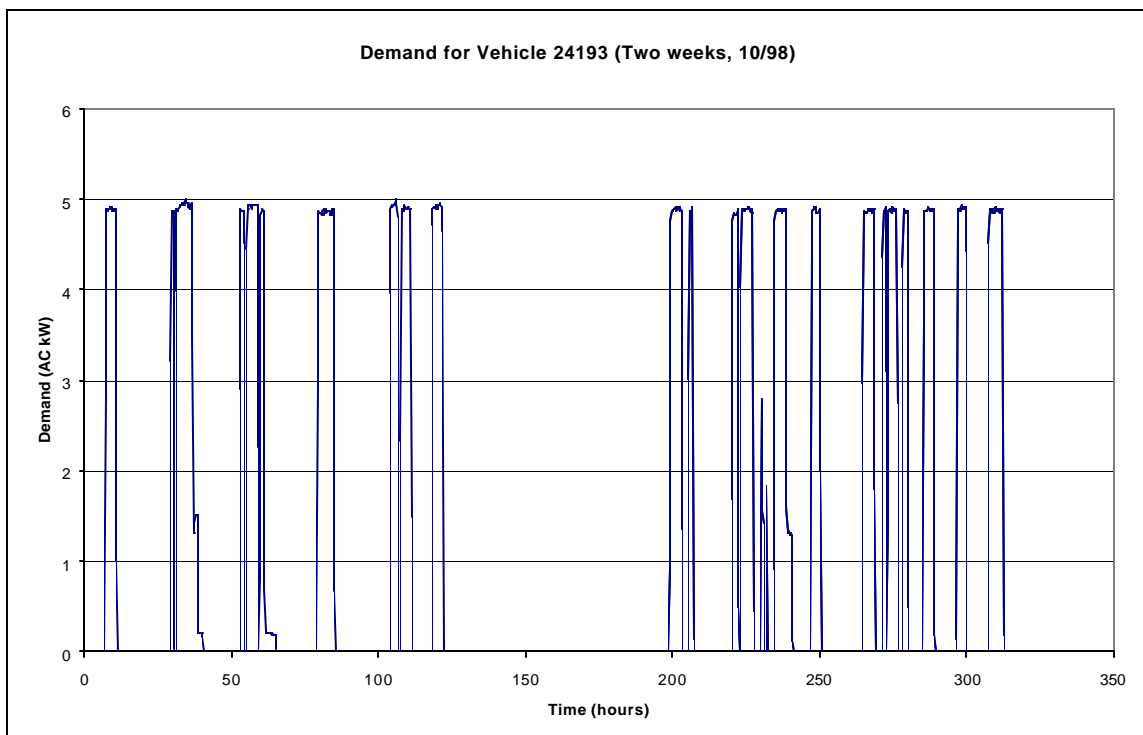
**Figure 10.** AC kWh demand for Vehicle 3 (two weeks).
